Subject: Gold King Mine Spill - brief background and initial EPA Region 9 response (internal - do not

release)

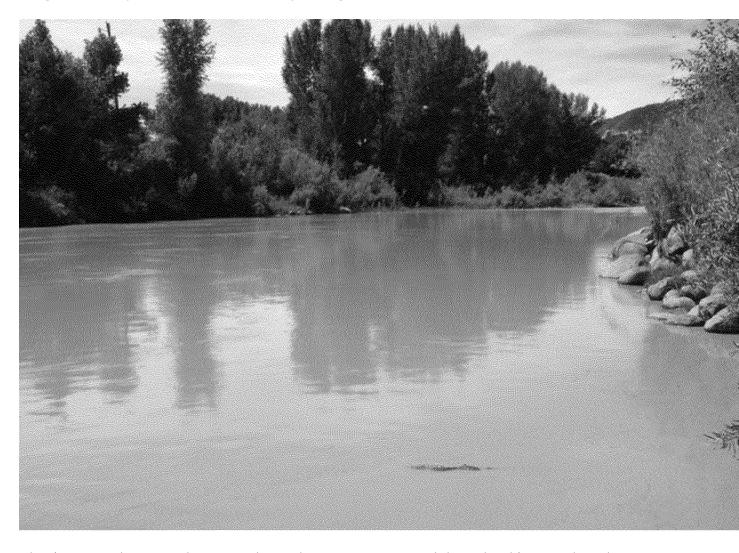
The river turned a mustardy-Tang color as the wastewater moved through. This was taken about 24 hours after the spill.

The mustard-Tang plume was the result of approximately three million gallons of wastewater and sludge that had poured from the dormant Gold King mine into Cement Creek, a tributary of the Animas, some 50 miles upstream on the previous morning. The water had backed up in the mine behind a sort of dam formed when the mine portal's ceiling had collapsed sometime earlier. Workers from the Environmental Protection Agency were hoping to install a pipe to drain the water so that they could eventually plug the mine, keeping the contaminated water inside it and out of the streams. Instead, they ended up accidentally breaching the dam, releasing the water.

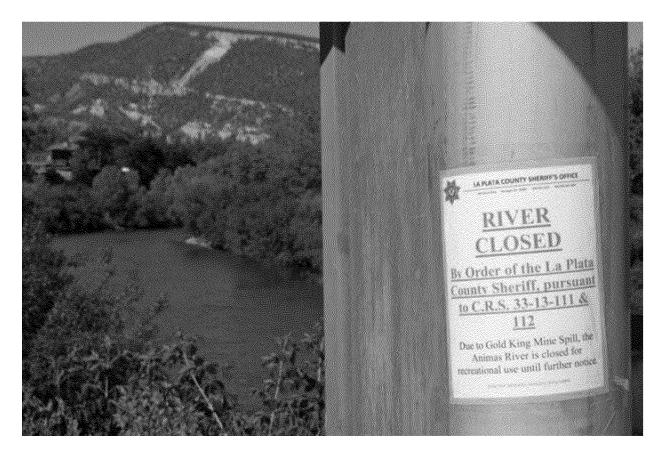
The Animas River was closed for public safety as the wastewater plume moved through town.

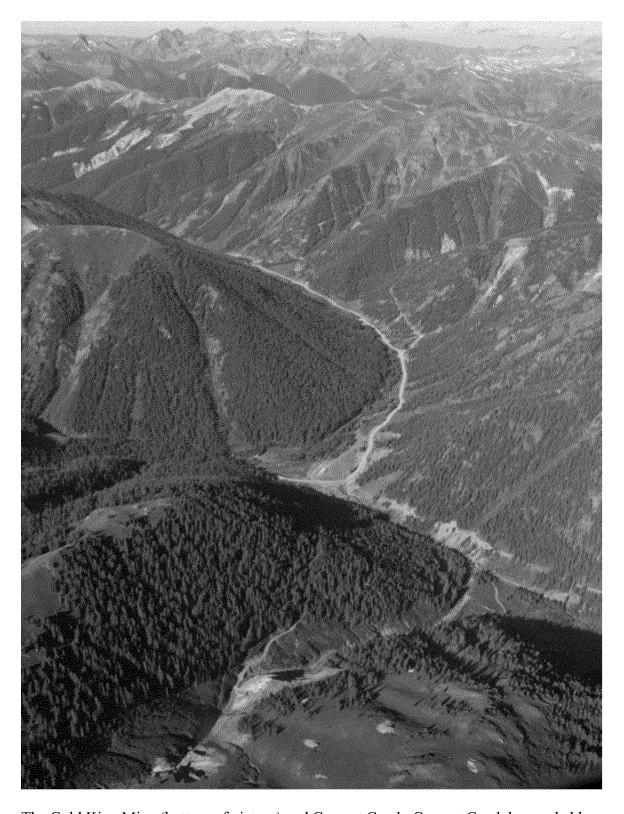
The Gold King Mine (bottom of picture) and Cement Creek. Cement Creek has probably never supported fish, and even before the spill had a pH level of about 3.5, on par with Coca-Cola.

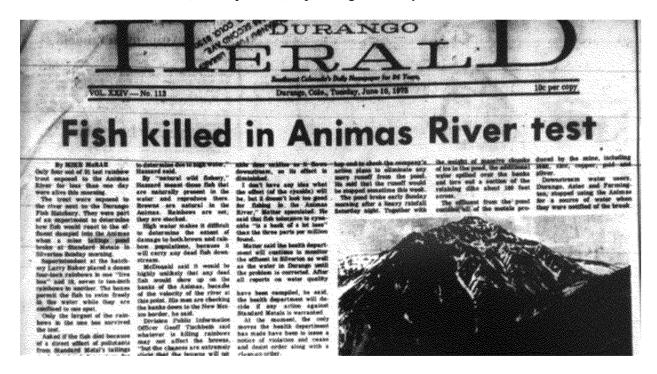
- This isn't the first time that something like this has happened, nor is it the worst: In June of 1975, a huge tailings pile on the banks of the Animas River northeast of Silverton was breached, dumping tens of thousands of gallons of water, along with 50,000 tons of heavy-metal-loaded tailings into the Animas. For 100 miles downstream, the river "looked like aluminum paint," according to a *Durango Herald* reporter at the time; fish placed in a cage in the water in Durango all died within 24 hours. It was just one of many breaches of various magnitude. Just a decade before, the same tailings pile was found to be spilling cyanide-laced water into the river.

A 1975 tailings pile breach just above Silverton sullied the Animas River for 100 miles downstream, turning the water the color of " aluminum paint" and killing fish.

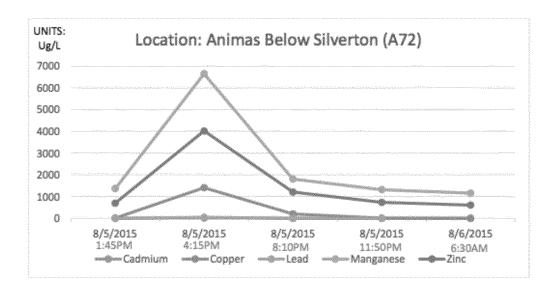
• Short-term impacts aren't as bad as the water looks: Sampling done by the EPA upstream from Durango show that the plume's peak put the Animas River's water's acidity on par with black coffee, and contained elevated levels of iron, manganese, zinc and copper. But by the time it reached town, the acidity had been diluted significantly, and levels of those metals were far lower, but still "scary," according to EPA officials. Still, the plume moved through quickly, lessening harm. A test by Colorado Parks and Wildlife, in which trout in cages were placed in the river prior to the plume's arrival, has so far shown no acute effects: Only one of 108 fish had died during the first 24 hours in contaminated water. Meanwhile, the Mountain Studies Institute has been monitoring macro-invertebrates, and their results have been similarly positive.

Samples taken by the EPA as the plume moved through show that it has high levels of heavy metals.

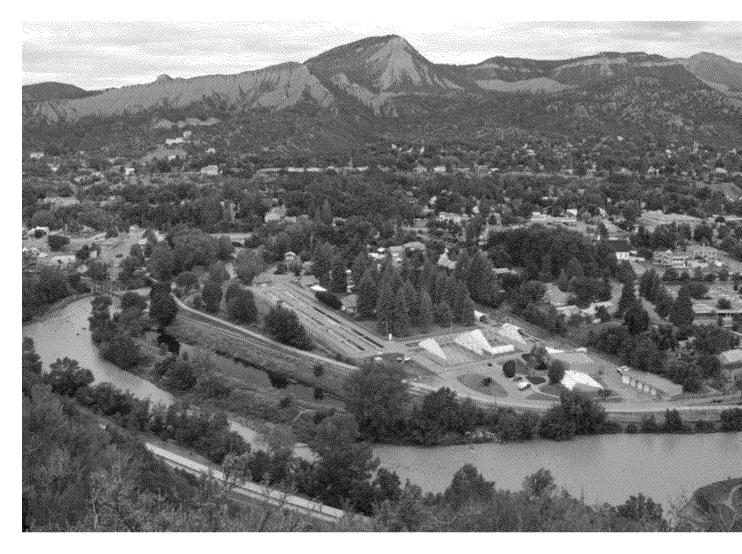
The contaminated Animas River as it runs through Durango. Note the contrast between the river and a fish hatchery pond next to it.
